BULLETIN

INTERNATIONAL RAILWAY CONGRESS

A contribution to the study of rail corrugation,

By CH. FRÉMONT.

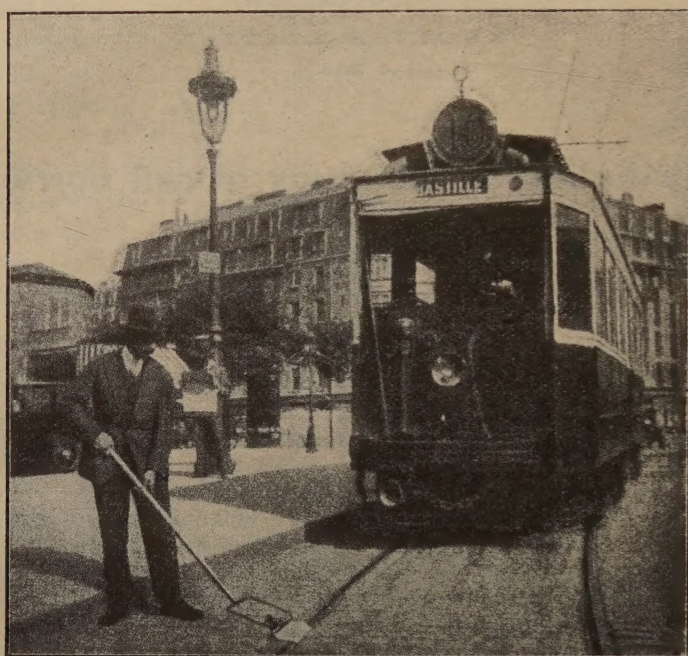
Fig. 1. — Device for taking on a sheet of paper an impression shewing the distribution of the pressures on the surface of a rail during the passage of a wheel over it.

In a previous article published in the *Génie Civil* on the investigation into the first beginnings of corrugated wear of rails ⁽¹⁾, I described the arrangement I had been led to devise for taking on a sheet of paper an impression shewing the distribution of the pressure on the surface of a rail during the passage of a wheel over it. Figure 1 shews the method of putting in place by means of a clip holder the thin sheet of paper, which will record the impression caused by the tram wheel running over it on the rail.

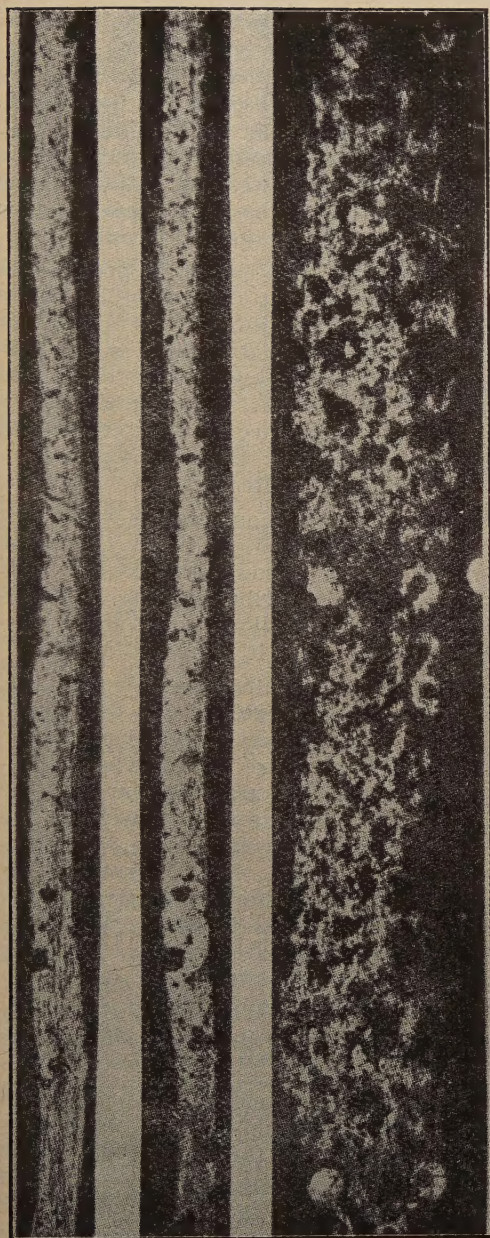
Fig. 2.—Impression
of wheel tread
on level rail.
Speed : 17 km.
(10.6 miles per hour).

all the impressions at the *same position on the rail*. Figures 2, 3 and 4 are full size photographic reproductions of these impressions. Figure 2 is an impression taken on the rail the running surface of which has just been put into good order, during the passage of a wheel at a speed

An inspection of the impressions (figs. 2 and 3) taken before there was any trace of corrugation, and whilst the rolling surface was perfectly level, enables us to explain from the distribution of the pressure on the rail what is the phenomenon first causing corrugated wear.

The two impressions (figs. 2 and 3) shew that the corrugations of this rail are superimposed because the impressions of small rust nodules, by which the position at which the impressions taken are located, can be noticed as recurring at their respective positions on the corresponding corrugations: this is not at all a matter of chance as the same fact is observed on other impressions taken at the same point under

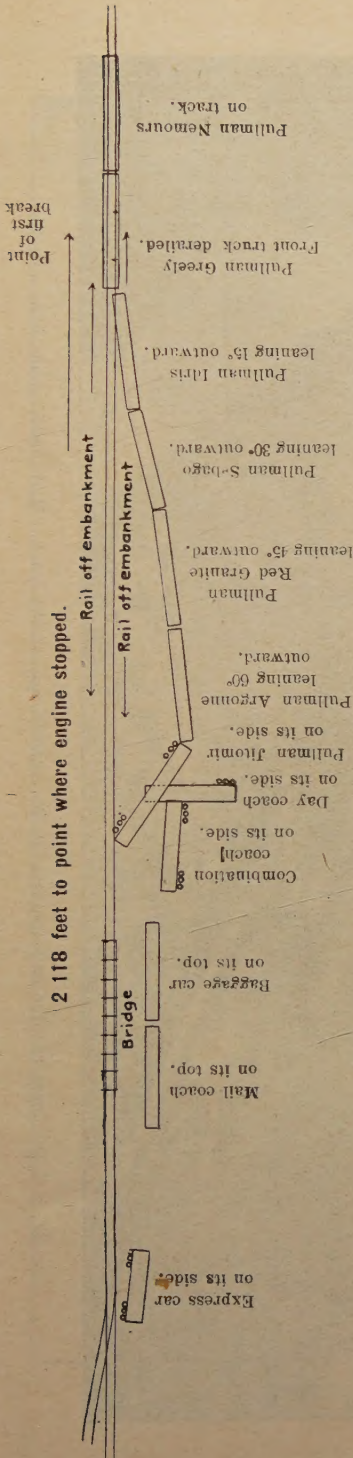
Fig. 1. — Plan of the track showing positions occupied by the derailed cars.

Figure 1 is a plan of the track taken from a blue print from the office of the

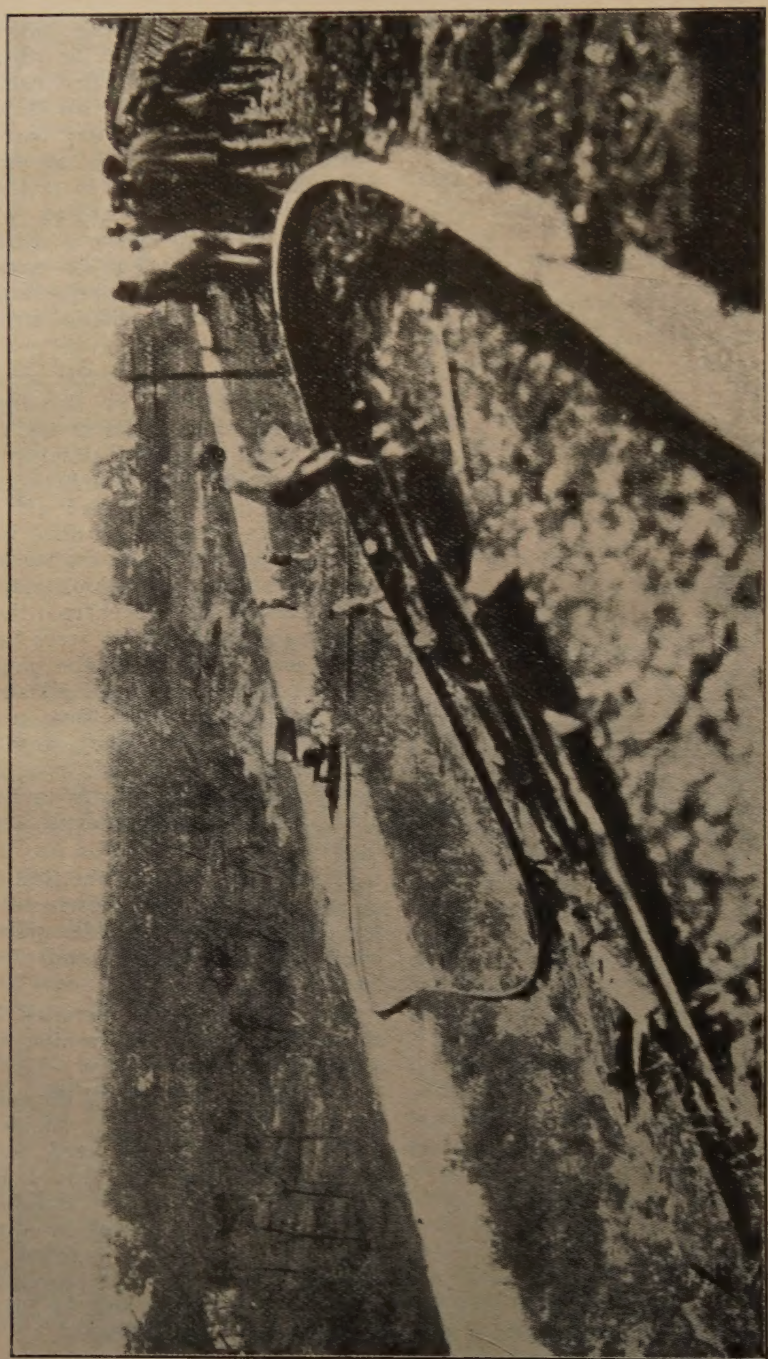
Fig. 2. — Loop made by nine rails plowed off the easterly side of the track. Rails bent, splice bars unbroken.

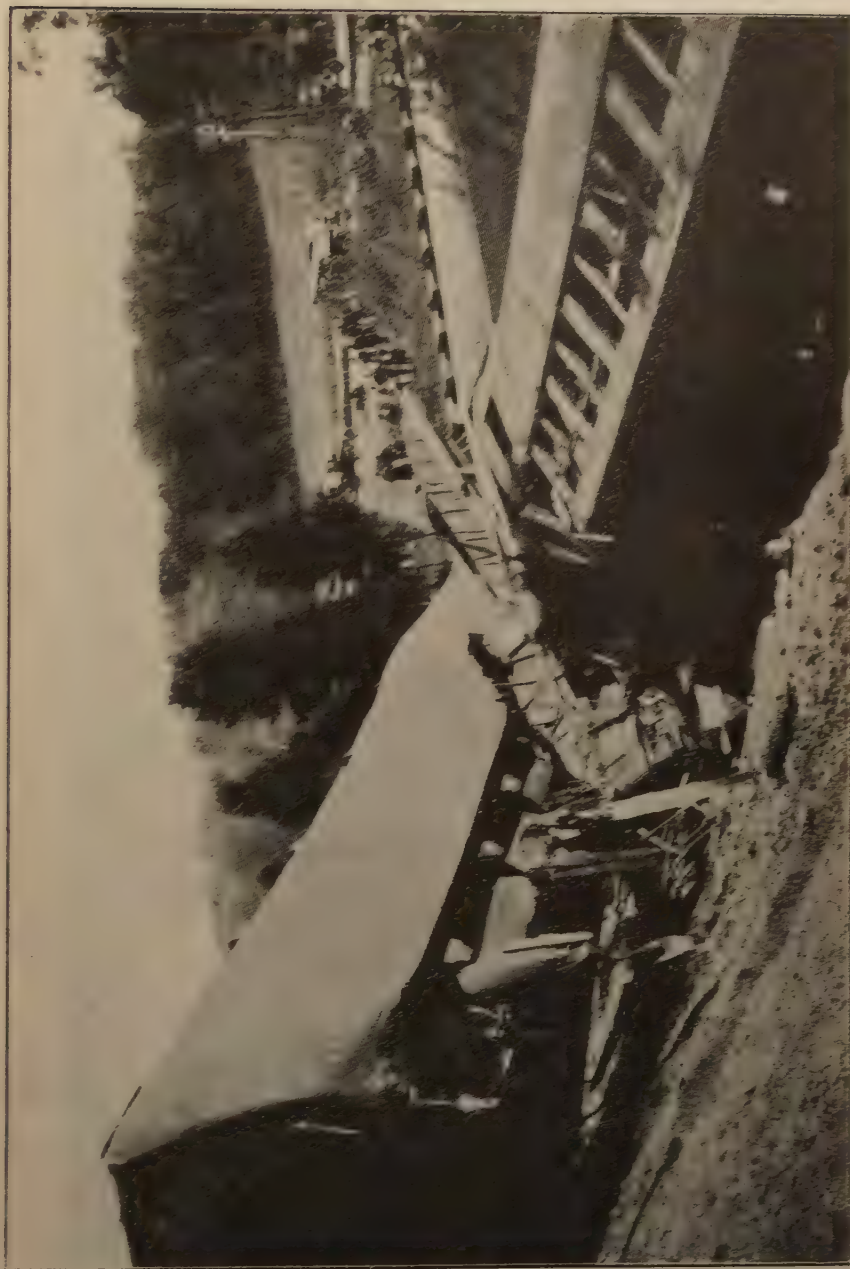
Fig. 3. View of the Pullman sleeper the Jilomir and a day coach. Middle of Pullman sleeper and end of day coach jammed together.

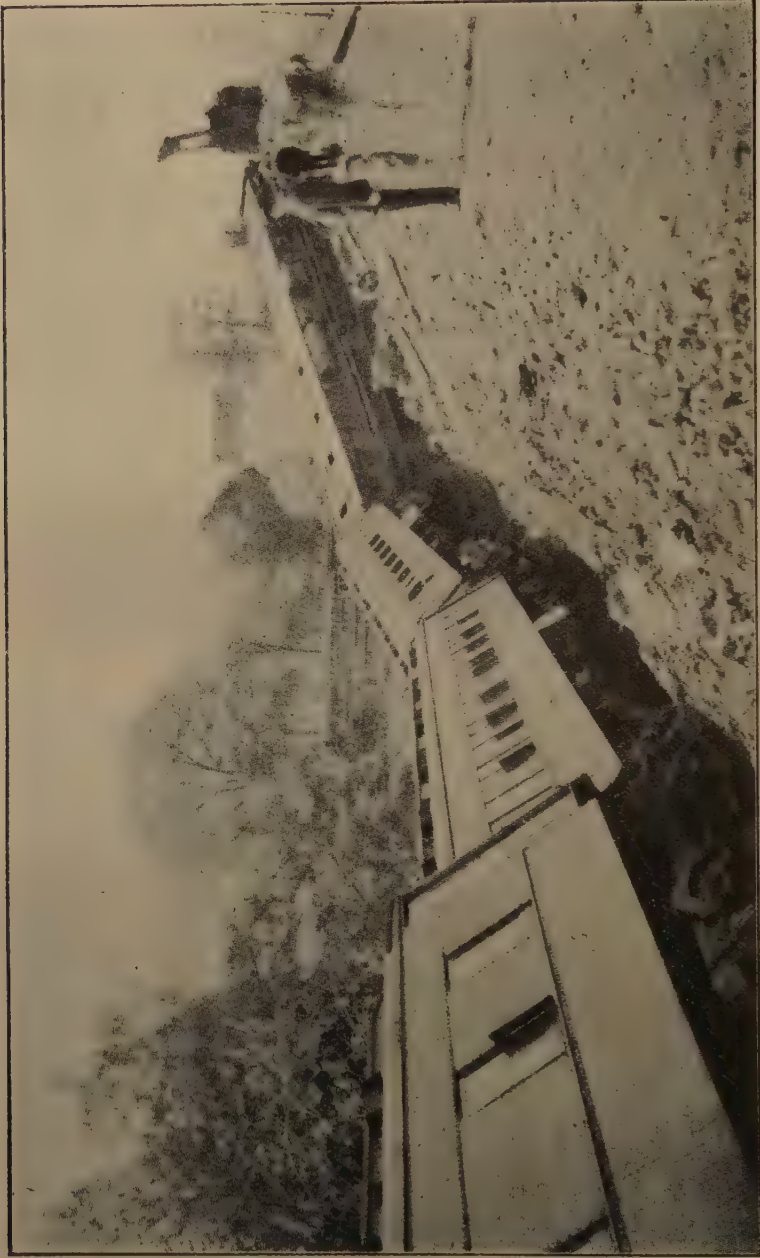
Fig. 4. — View of the derailed Pullman sleepers Sebago, Red Granite, Argonne and Jitomir, respectively.

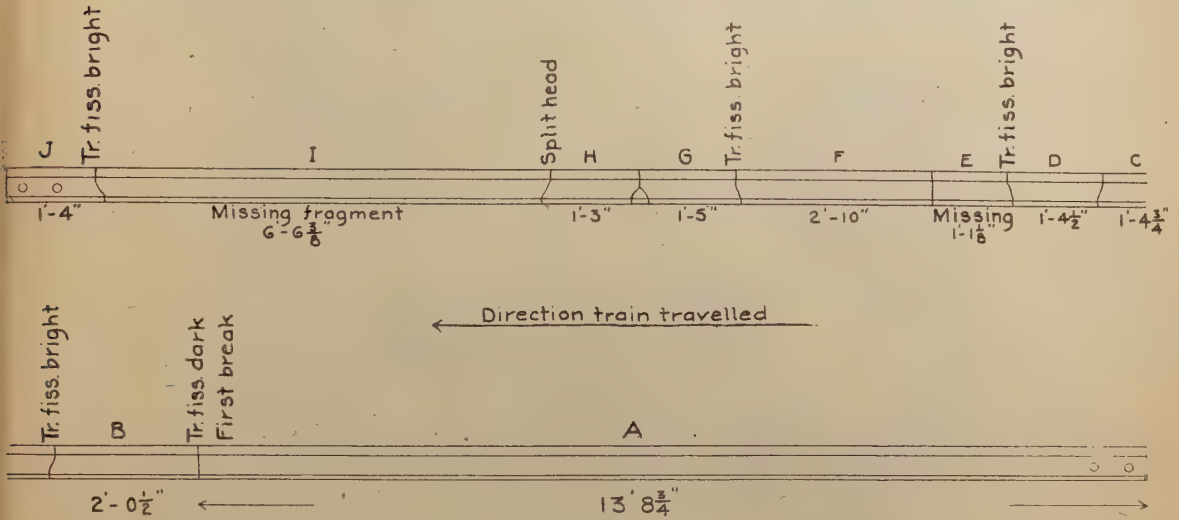
Fig. 5. — Drawing of the rail which caused the accident, showing location of fractures made in the track.
Rail branded O. H. Tenn. A. S. C. E. 9040 10 1918. Heat number and ingot letter 17054 C.

Figure 5 is a drawing of the rail which broke and caused the accident. It weighed 90 pounds per yard, was rolled by the Tennessee Coal, Iron & Railroad Company, in the month of October, 1918, and was laid in the track in April 1919. It had been in service, therefore, 6 years and 6 months. It was branded O. H. Tennessee A. S. C. E. 9040 10 1918. Heat number 17054, ingot letter C.

Fragment F of rail 17054 C, figure 5, was used in an examination of the structural state of the steel at different depths below the running surface of the head. The metal was planed off in successive stages and the rail pickled in hot hydrochloric acid at each stage. Figure 10, *a*, *b*, *c*, and *d* are photographic views of the pickled surfaces at depths of 1/2, 5/8, 3/4, and 7/8 inch, respectively. The surface was clear at a depth of 1/2 inch. A few crosswise cracks appeared at 5/8-inch depth. Again the head was nearly clear at 3/4-inch depth. At 7/8-inch depth numerous cracks appear-

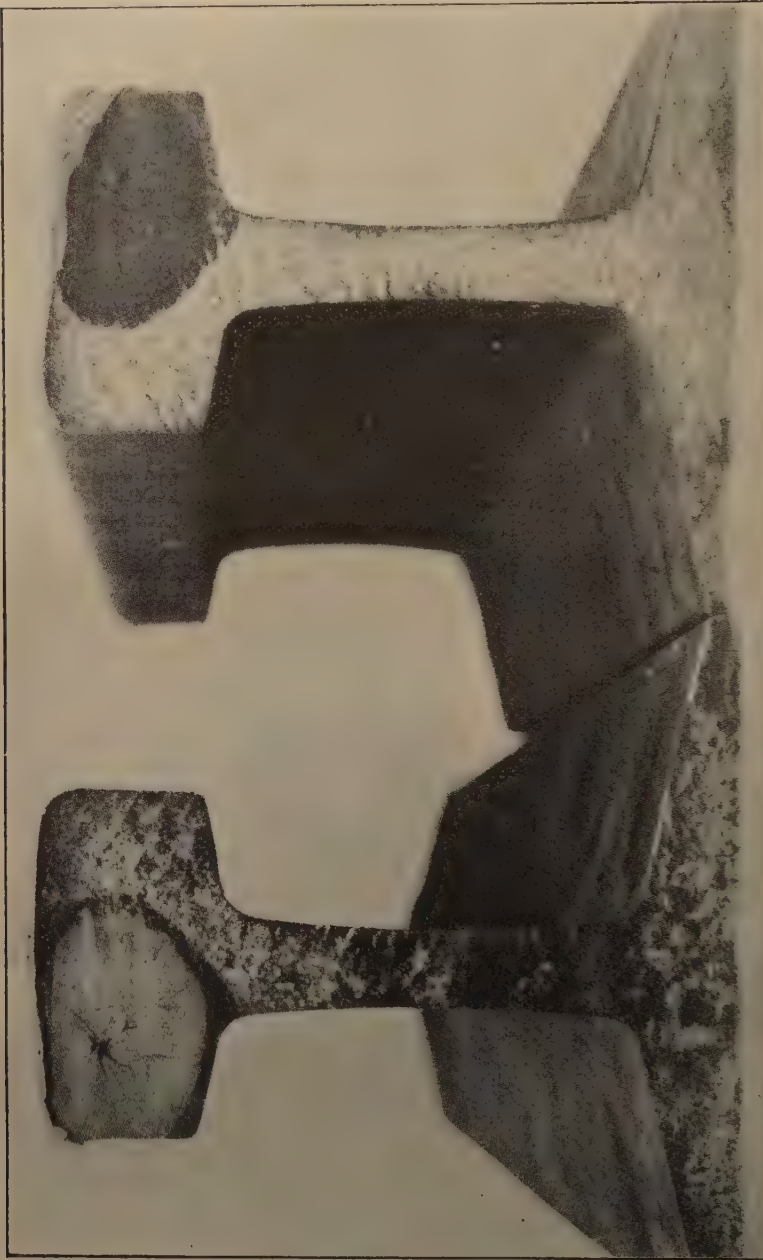
Fig. 6. — Appearance of the opposite faces of the transverse fissure first to break.
Leaving and receiving ends, respectively, of fragments A and B.

There was a transverse fissure at the first break in the rail which measured $1 \frac{13}{16}$ by $1 \frac{7}{16}$ inches. The surfaces were darkened, indicating the fissure

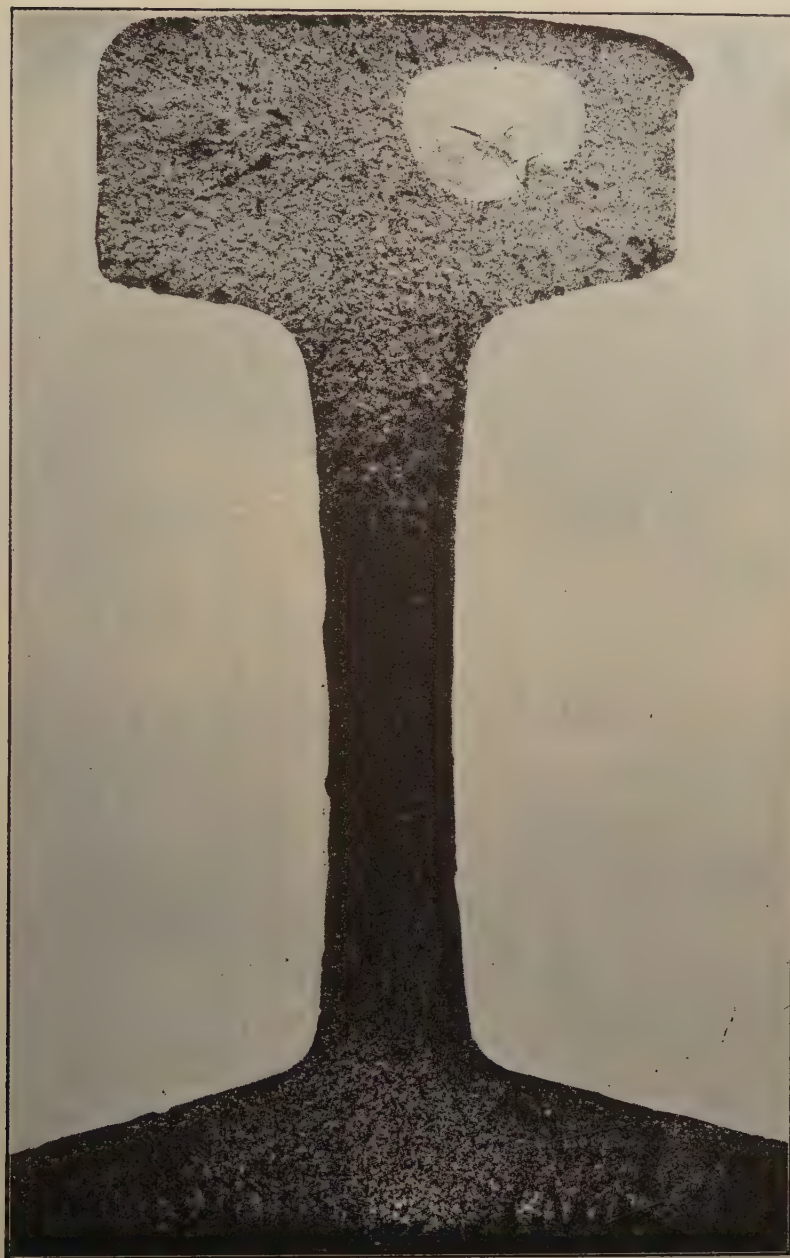
Fig. 7. — Partially formed transverse fissure revealed by hammer test of fragment A.

The manner of conducting the hammer tests was to place the rail, head down, on supports at the edges of the anvil and strike the rail on the base midway the supports, repeating the blows at short intervals along its length. Continuing the hammer tests, other rails were examined which came from the destroyed section of the track. Eleven rails were tested, five of which had the same heat number as the rail which first

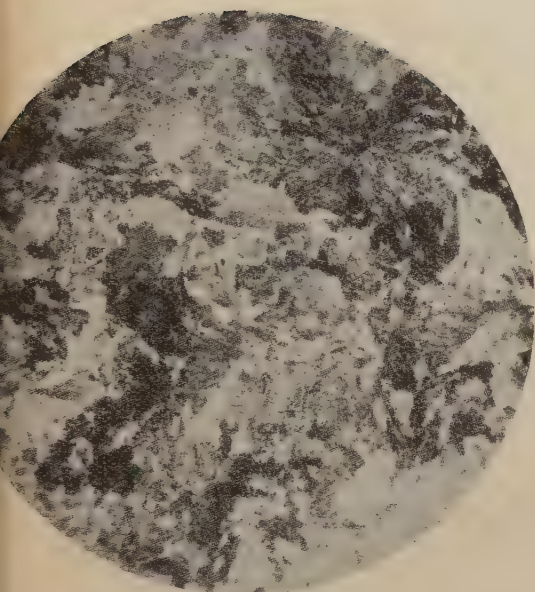
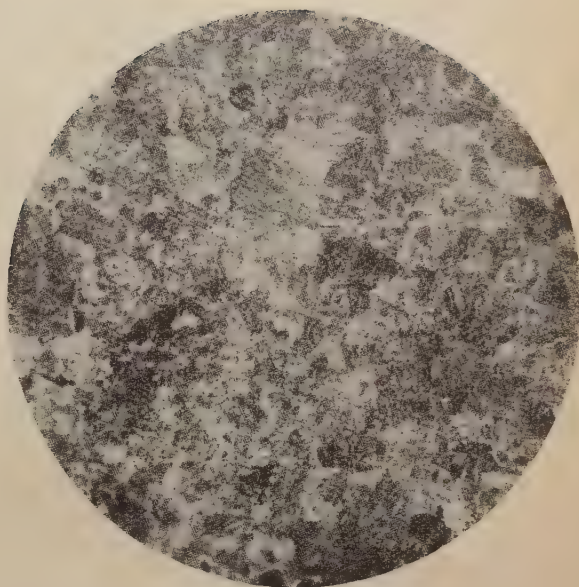
Fig. 8 — Microstructure of rail 17054 C, zone of transverse fissure and opposite side of head.
Magnification 100 diameters.

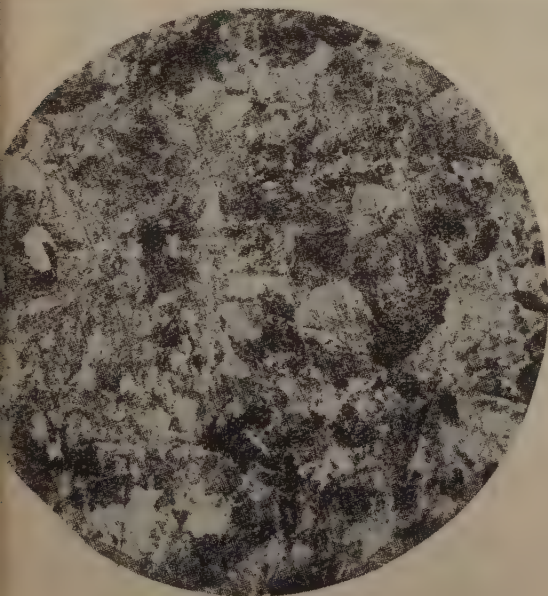
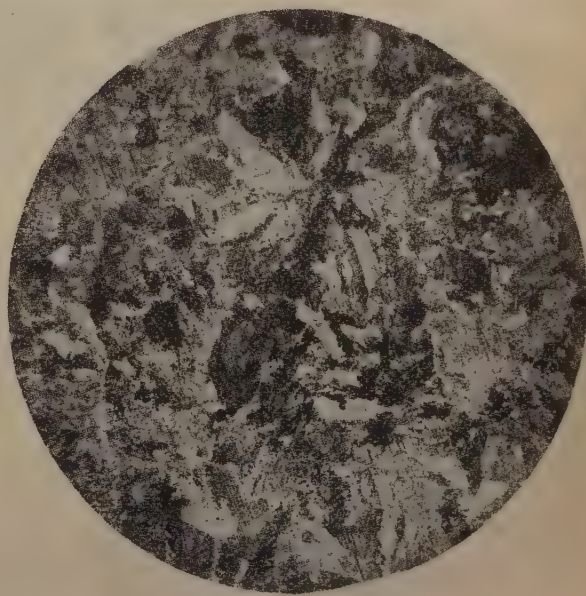
Fig. 9 — Microstructure of rail 17054 F, zone of transverse fissure and opposite side of head.
Magnification 100 diameters.

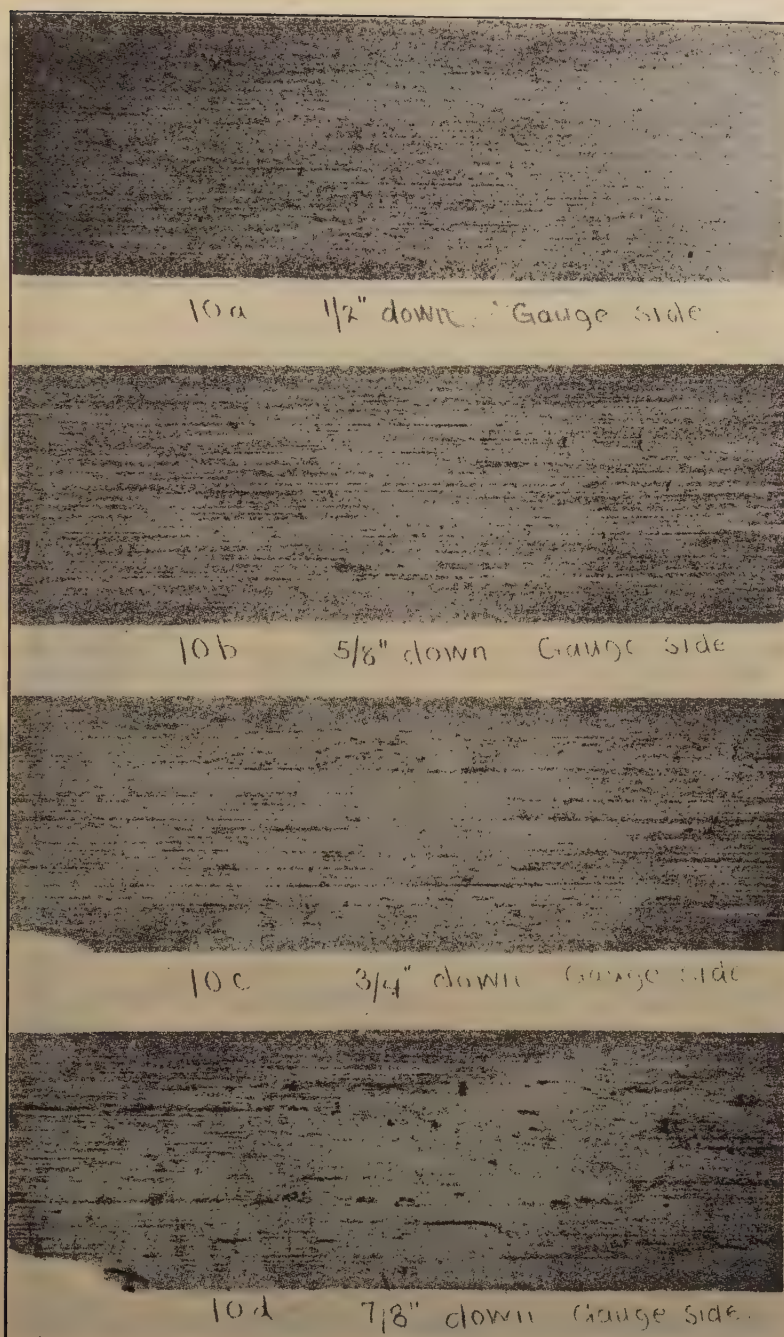
Fig. 10. — Head of rail 17054 C, fragment F, planed off in successive stages; surface pickled at each stage.

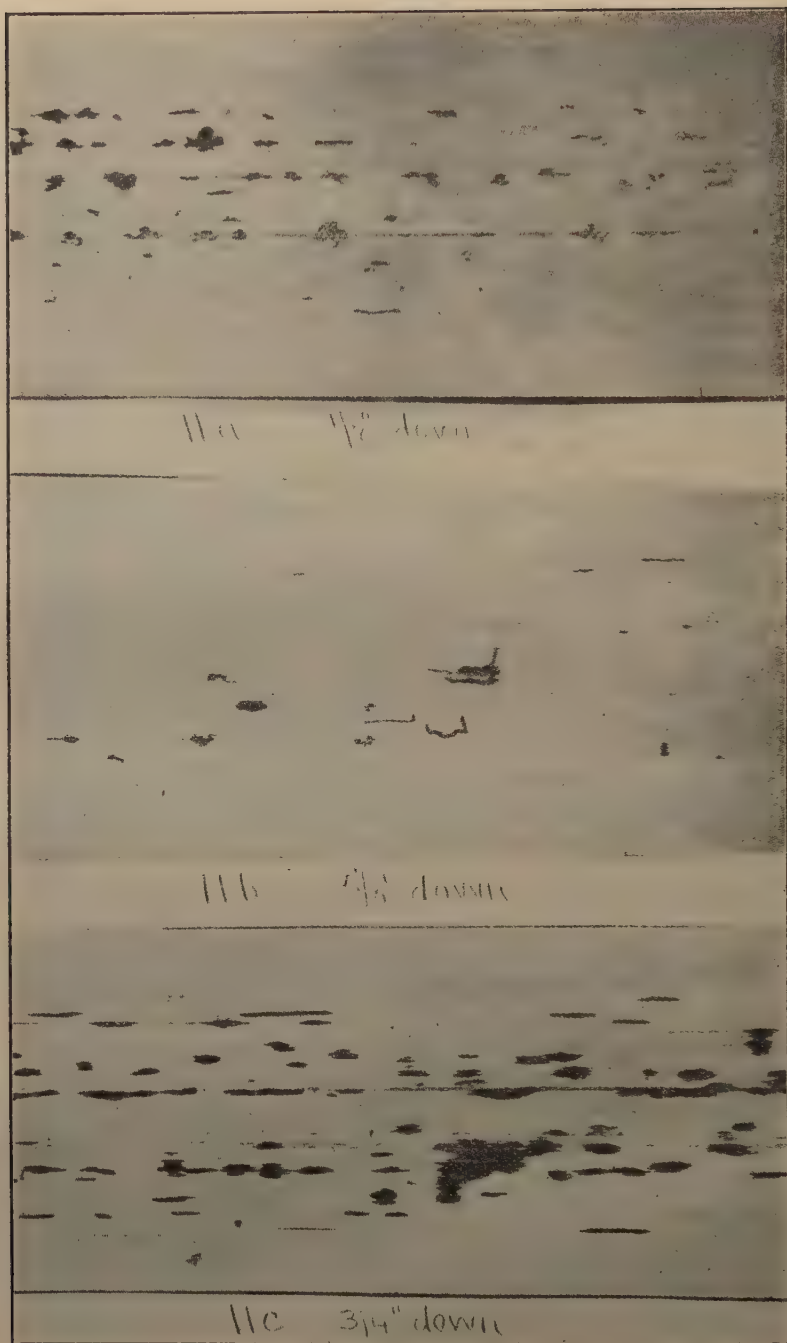
Fig. 11. — Head of rail 47054 C, fragment C,
planed off in successive stages; surface pickled at each stage.

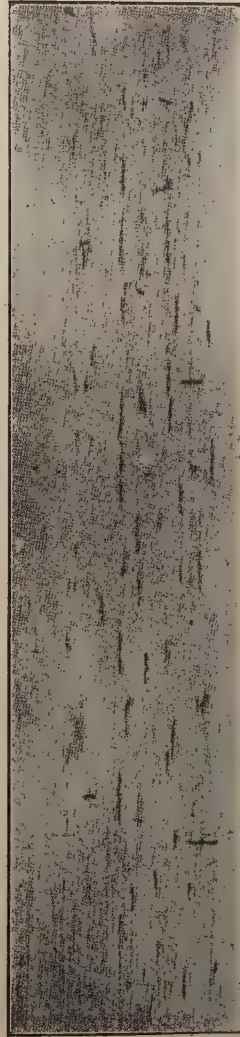
Fig. 13. — Head of 130-pound rail planed off $\frac{3}{4}$ inch and surface pickled.
Incipient transverse fissures from gauge side inward, also longitudinal slag cracks.

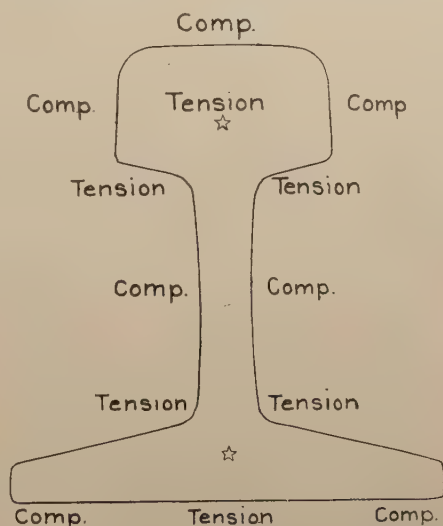
Fig. 15. — Locations of strains of compression and tension in rails of normal cooling. Stars indicate zones where shrinkage cracks occur.

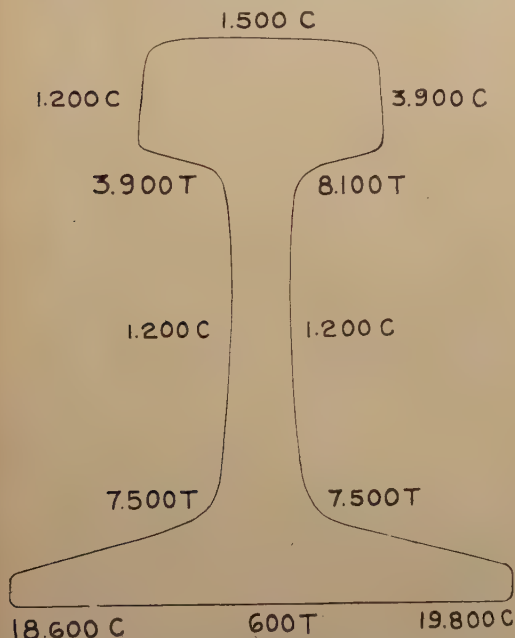
Fig. 16. — Stresses corresponding to the cooling strains of fabrication in a medium manganese steel rail, weight of rail, 127 pounds per yard. Manganese content, 1.67; carbon, 0.68.

Numerical values, stresses pounds per square inch, representing the cooling strains of fabrication are illustrated by figure 16 for a rail cooled normally in air. The stresses here given were present in a 127-pound medium manganese steel rail. The manganese content was 1.67, carbon 0.68. Compression stresses of moderate degree prevailed in the periphery of the head. Tensile stresses not measured in the central core of the head, required to balance the external stresses, were necessarily of moderate degree. Tensile stresses were displayed at each of the fillets of the web, the intermediate portion of the web being in a state of initial compression. Higher stresses of compression prevailed in the edges of the flanges than elsewhere.

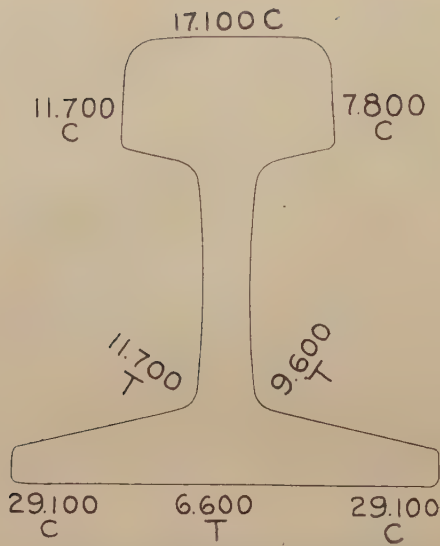
Fig. 17. — Initial stresses in a 100-pound rail, cooled by an air blast directed on the head; 10 pounds pressure of 4 minutes duration.

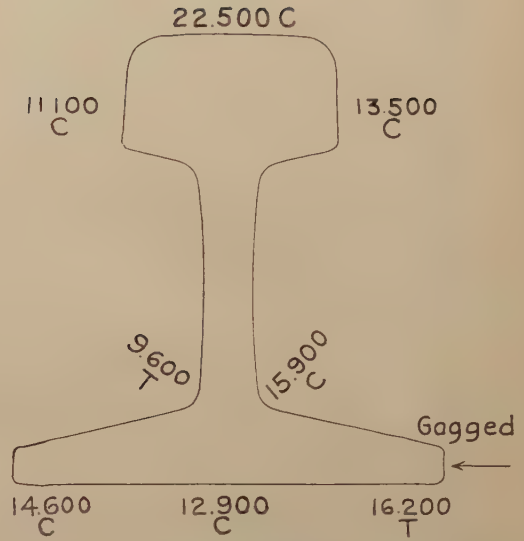
Fig. 18. — Initial stresses in a 100-pound rail reversed from compression to tension by the operation of gagging. Air-cooled rail same as figure 17.

Figure 18 illustrates the stresses in a

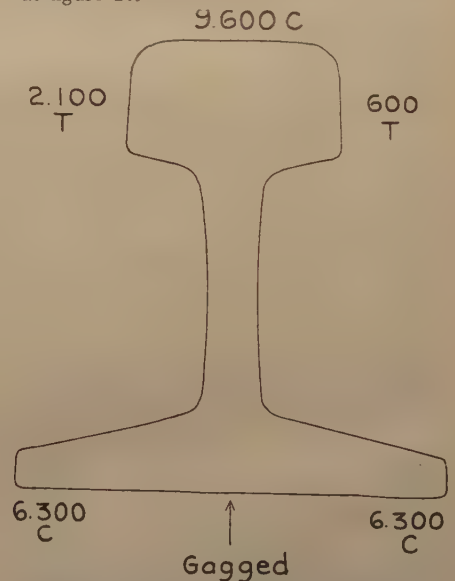
Fig. 20. — Initial stresses in a 100-pound rail after gagging on the base. Air cooled rail same as figure 19.

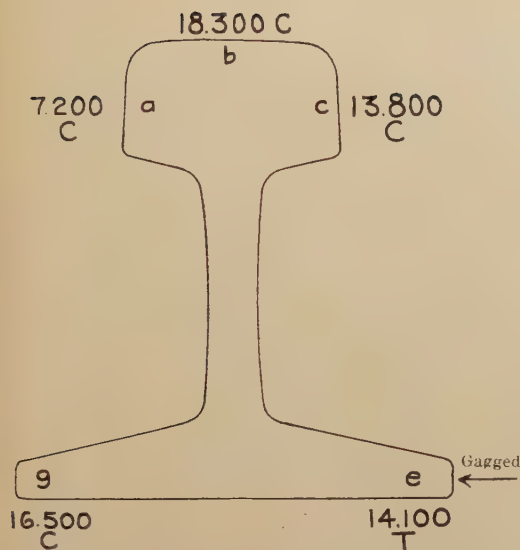
Fig. 21. — Initial stresses in a 100-pound rail air cooled gagged on a flange. Strip from head and base annealed.

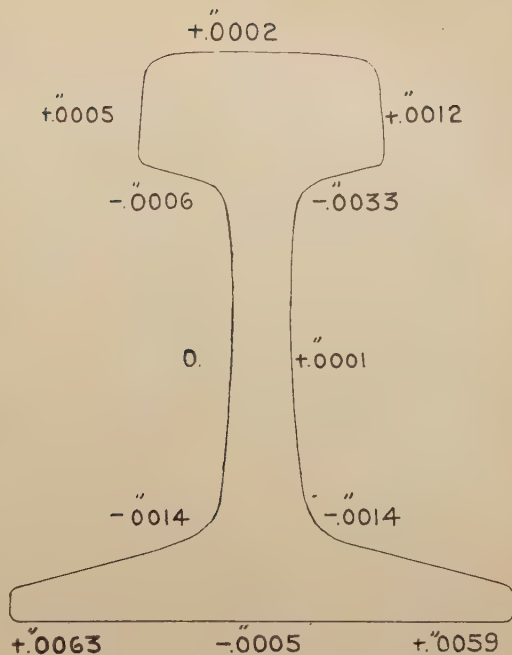
Fig. 22. — Measured strains in strips detached from medium manganese steel rail, 127 pounds per yard. Normally cooled.

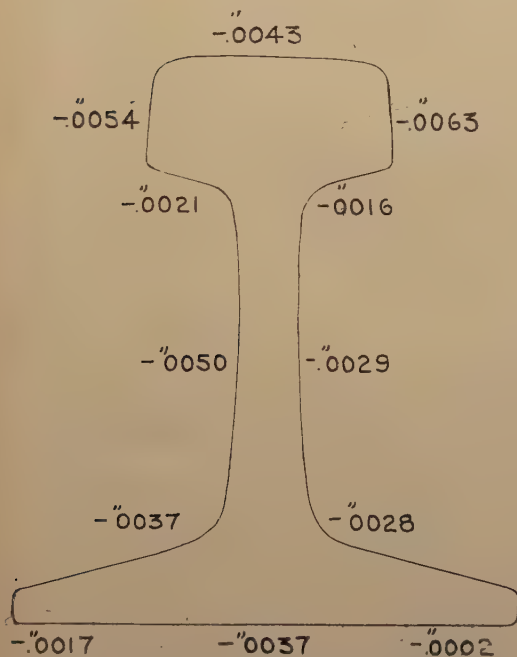
Fig. 23. — Changes in lengths of strips detached from medium manganese steel rail, figure 22, annealed.

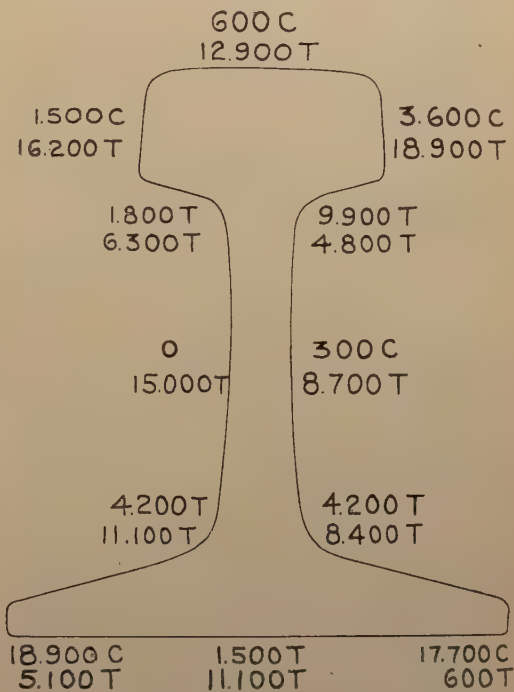
Fig. 24. — Stresses corresponding to the strains shown by figures 22 and 23.

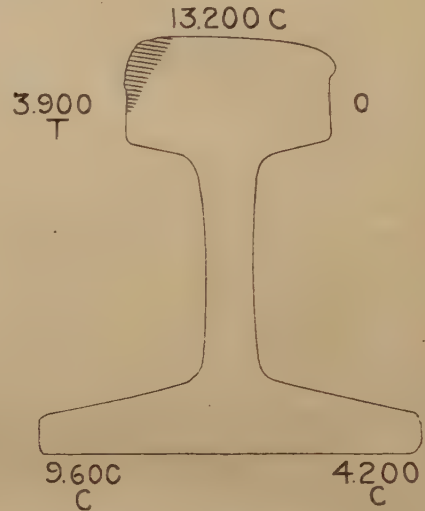
Fig. 26. -- Internal stresses in a 90-pound rail modified by brazing a bond wire on side of head.

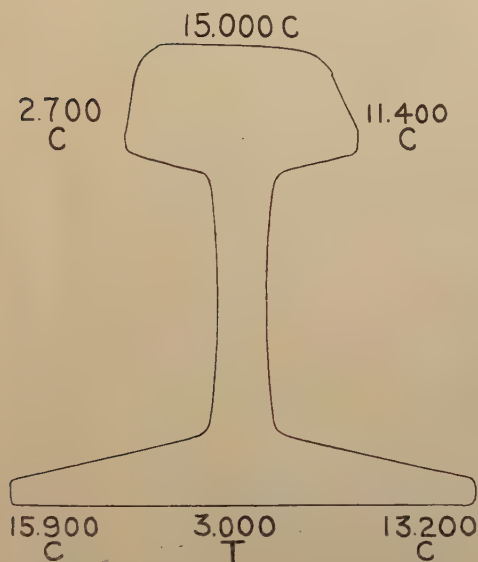
Fig. 27. — Internal stresses in a 100-pound rail from the tracks of the Interborough Rapid Transit Railroad, New York City.

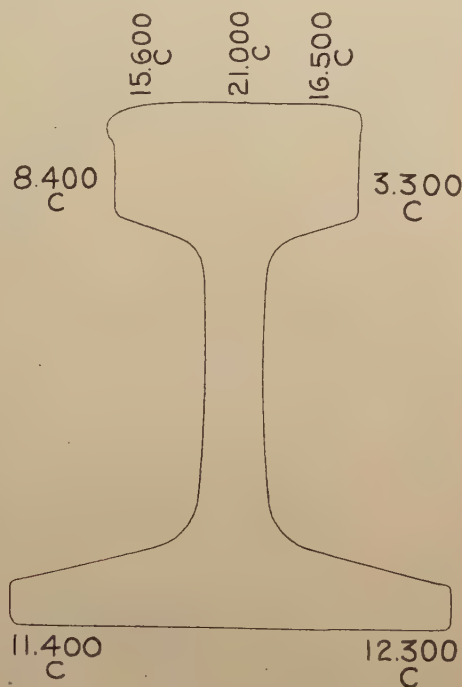
Fig. 28. — Internal stresses in a 130-pound rail, low rail of a 3° 40' 10" curve, after 16 months in service.

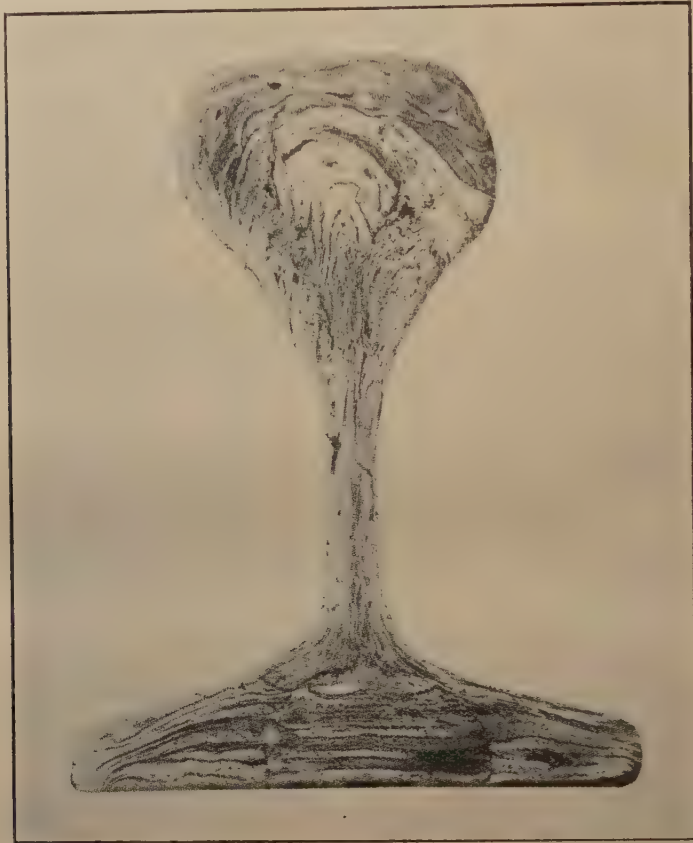
Fig. 29. — Cross section of an early wrought-iron rail, etched with tincture of iodine.
Internal stress in top of head 24 920 pounds per square inch compression.

Figure 29 illustrates the appearance, in cross section, of an early, puddled,

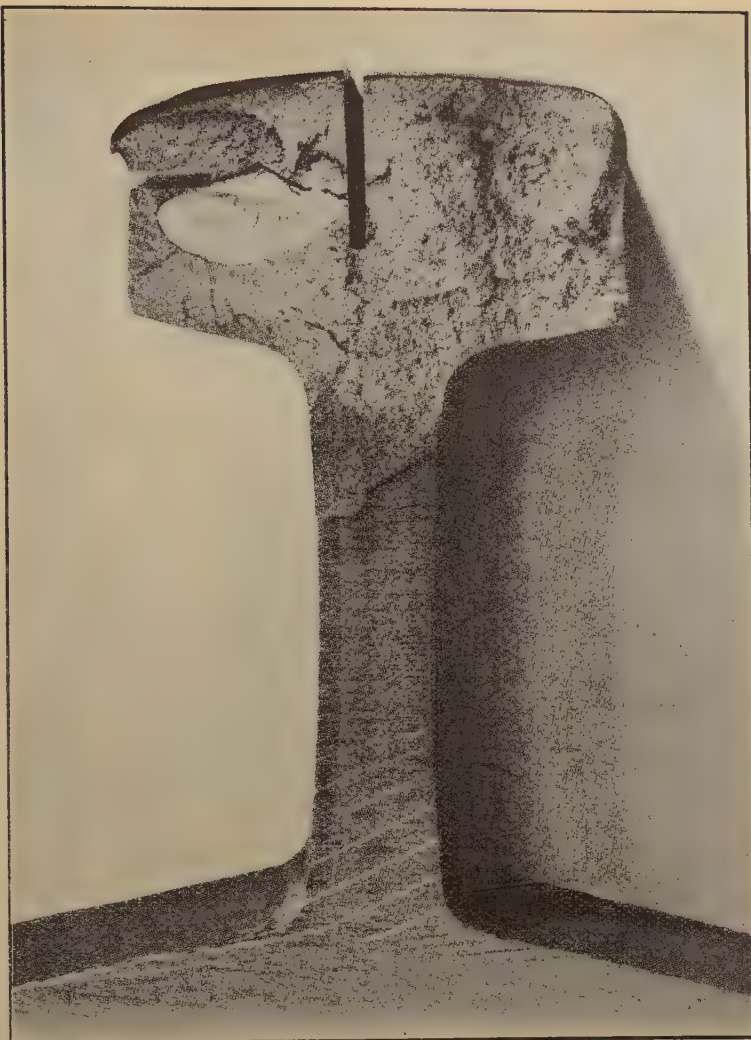
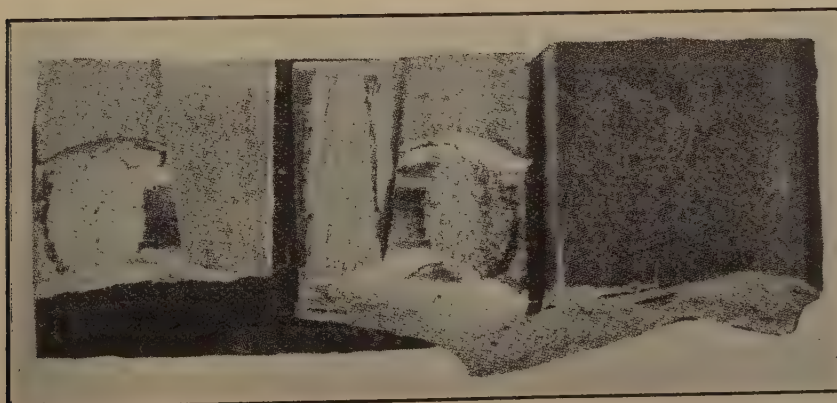
Fig. 30.

Figs. 30 and 31. — Compound transverse fissure originating at a small longitudinal seam.
 Vertical development shown by figure 30,
 horizontal oval fracture containing longitudinal seam shown by figure 31.

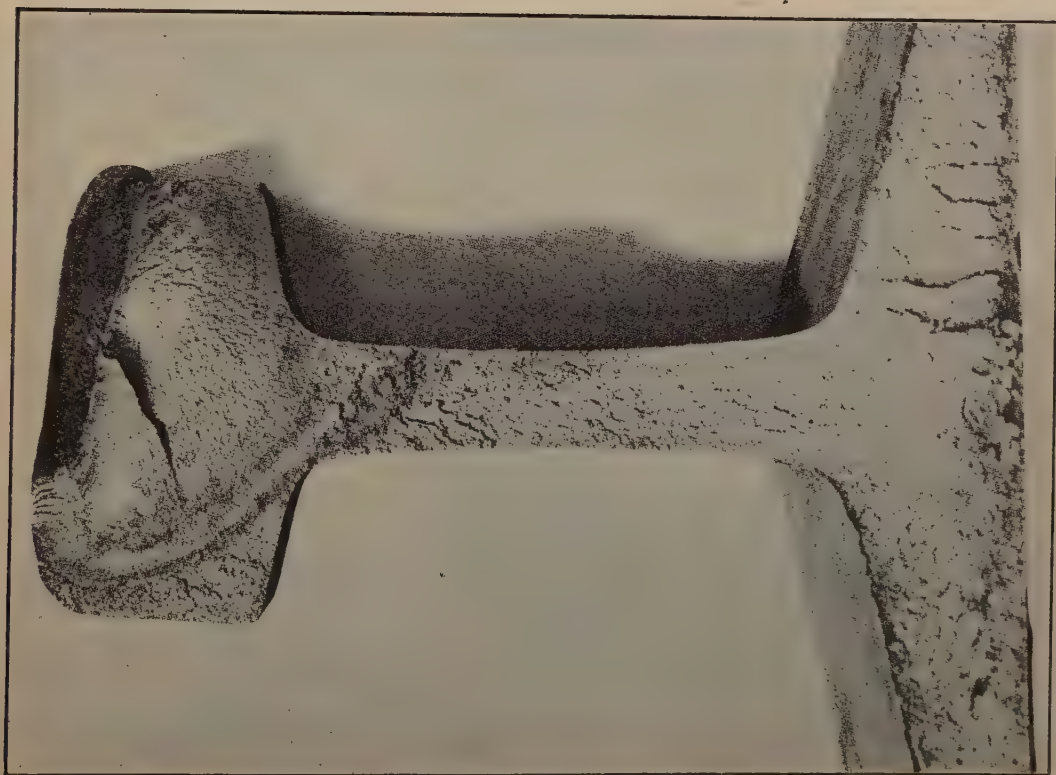
Fig. 34. — Compound transverse fissure in a 100-pound rail, originating at a horizontal split head.

Fig. 34, transverse fissure branching downward from split head. Fig. 35, two horizontal split-head cracks, the longer of which led to the formation of the transverse fissure.

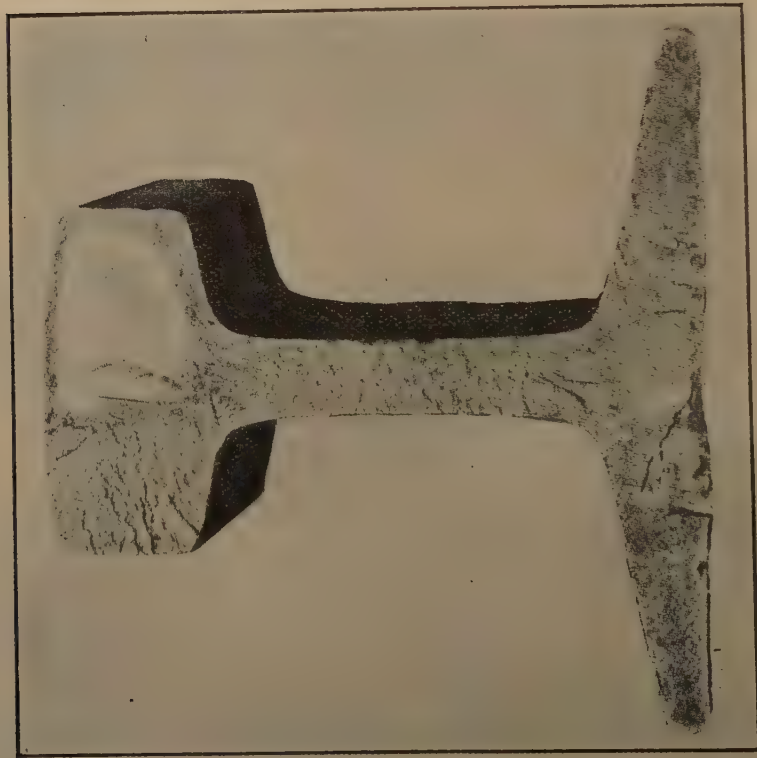
Fig. 36. — Transverse fissure in a 85-pound rail arrested at a split head fracture.

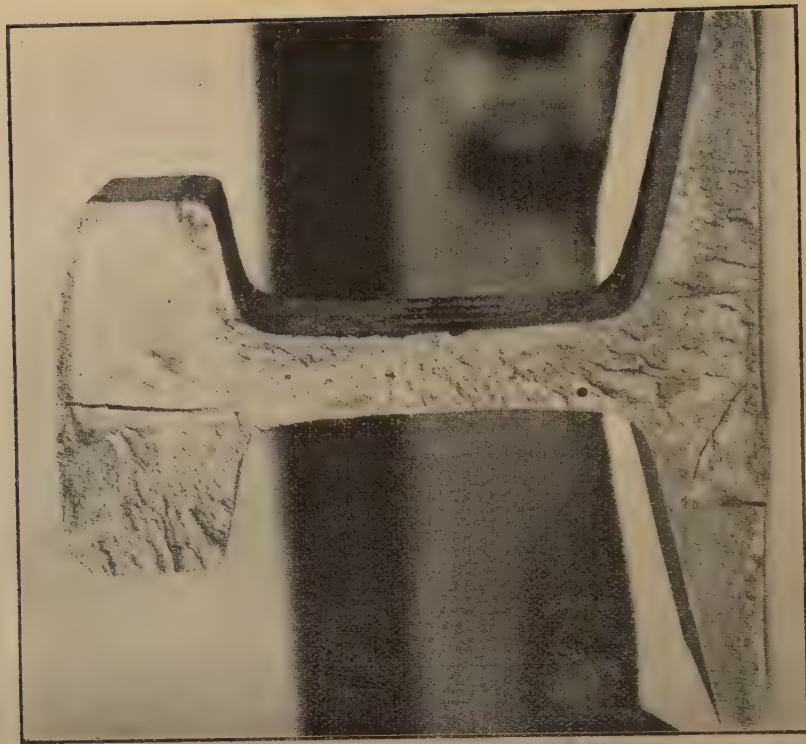
Fig. 37. — Split head fracture of figure 36 extended across transverse fissure by peening to running surface of head.

After photographing, the split head fracture was extended by mechanical means analogous to the action of wheel pressures. The top of the head was peened with a hand hammer, setting up strains of compression which eventually were sufficient to cause an upward extension of the crack. The peening was continued, along the middle of the length of this short section of rail, until the vertical crack reached the top of the head at each end of the specimen. Figures 37 and 39 show the results.

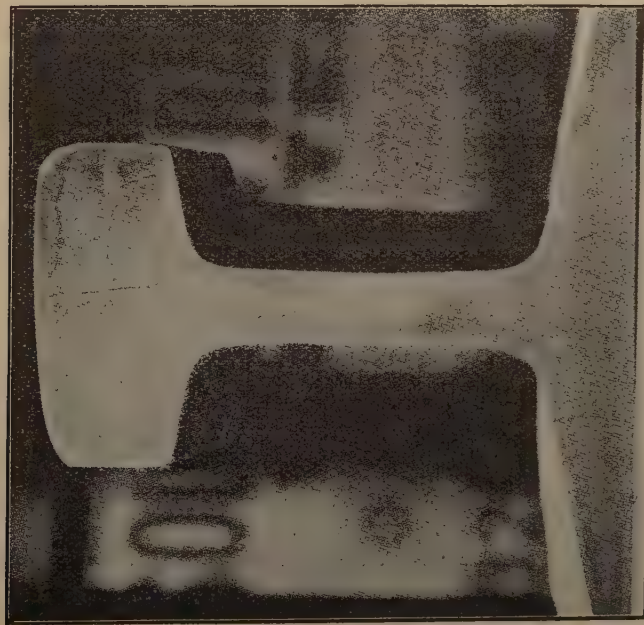
Fig. 38. — Split head fracture in an 85-pound rail.
Opposite end of short fragment figures 36 and 37.

Figure 38 represents the vertical crack in the head of the rail on the end opposite the transverse fissure which is shown by figure 36. After its further

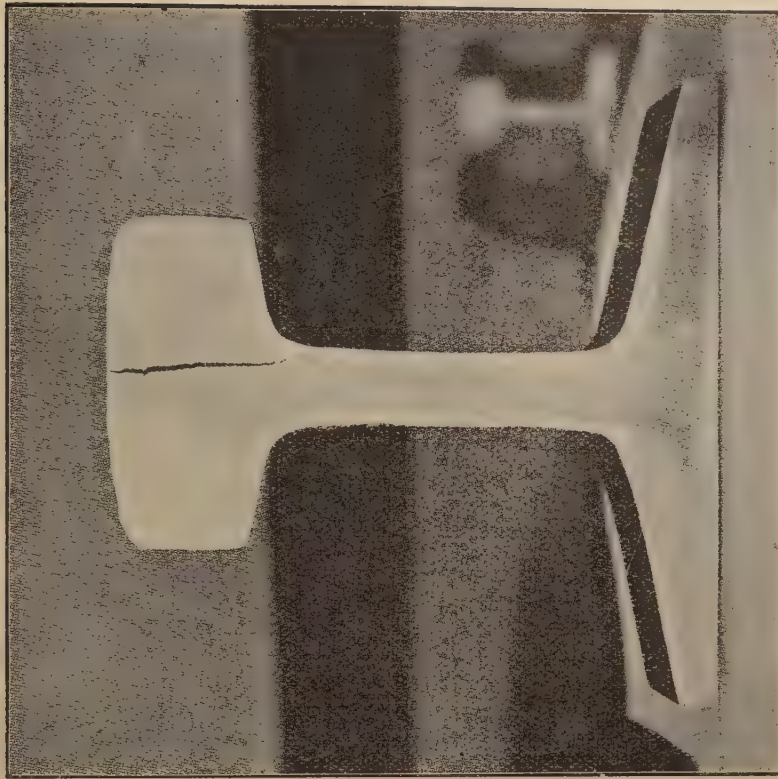
Fig. 39 — Split head fracture of figure 38 extended by peening to running surface of head.

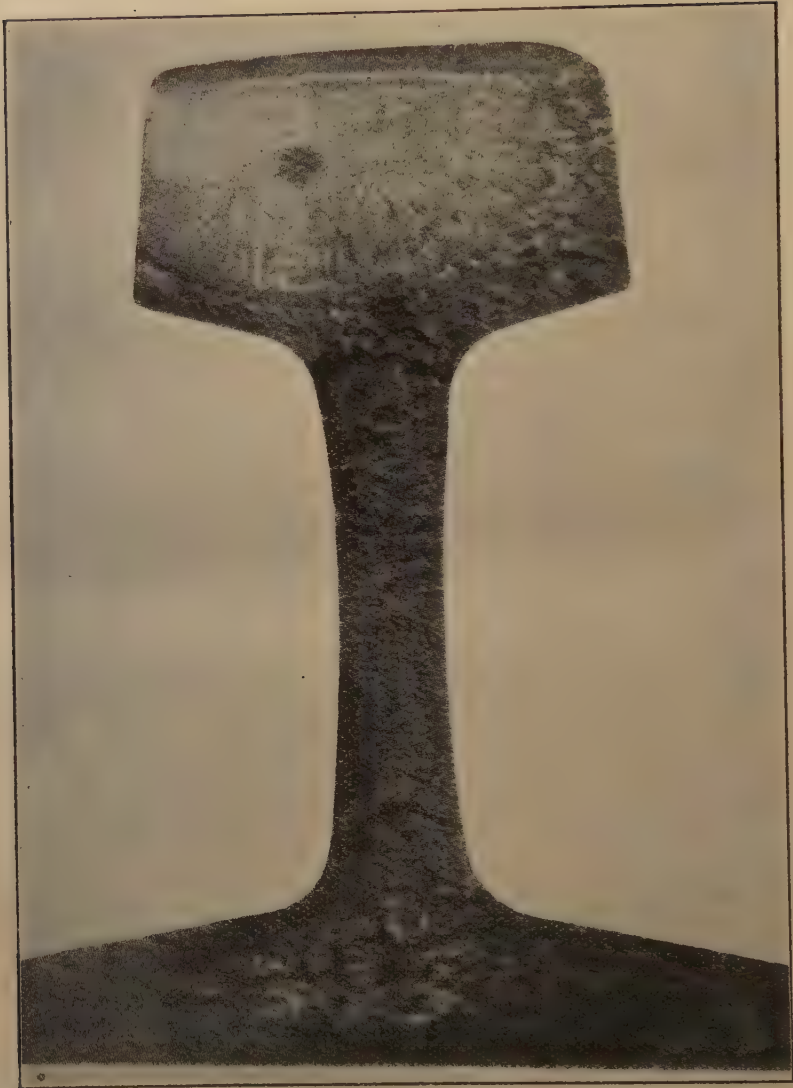
Fig. 40. — Transverse fissure in 100-pound O. H. vanadium steel rail.
Transverse fissure reached surface at side of head, but not running surface.
